FIFTH QUARTERLY PROGRESS REPORT
EVALUATION OF HIGH-STRENGTH LIGHTWEIGHT
LAMINATED PRESSURE VESSELS OF
LAP-JOINT CONSTRUCTION

10 April 1963

Period covered: 1 January to 31 March 1963
Republic Aviation Corporation
Farmingdale, L. I., N. Y.

TECHNICAL REPORT NO. WAL TR 766.2/3-4

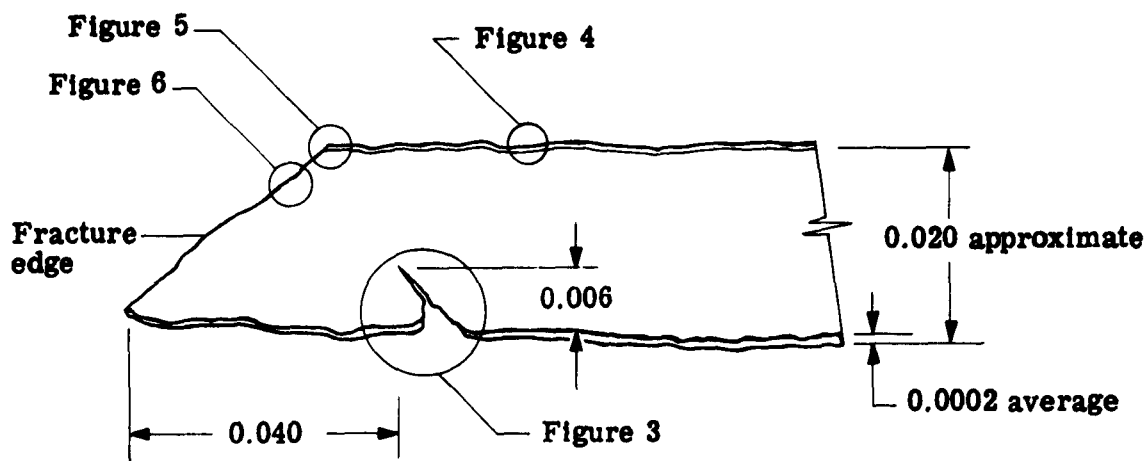
Figure 2. Edge View of Failure Origin and Locations of the Micrographs

From the data obtained, the cause of failure can be attributed to the following factors:

- 1) The presence of multiple discontinuities in the form of grooves and notches on the surface of the material
- 2) The presence of an isolated zone of light-etching, hard material of unknown origin

Figure 2 shows the location of the fracture origin relative to the secondary fracture as well as the relative location of the photomicrographs. Figure 3 shows the light-etching, hard zone devoid of structure. Evidence of the softer layer previously discussed is presented in Figures 4 and 5. Figure 6 shows the discontinuous nature of this layer.

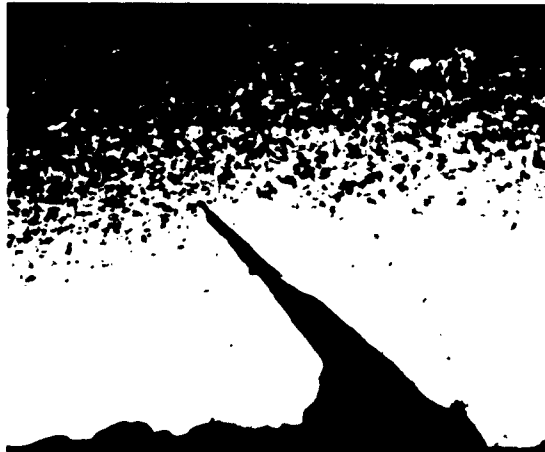
Figure 3. Secondary Fracture in 18-9-5 Mar-aging Steel (about 250X, Schantz Etch)

The appearance of the microstructure in Figure 3 is noteworthy. A microhardness traverse indicated that the lightly etched area contained two zones. The first was an outer soft layer from 0.0001 to 0.0003 inch in depth ranging in hardness from R_b (Rockwell b scale) 84 to R_c (Rockwell c scale) 29. The second area was harder (R_c 60 to 61) and extended to a depth of 0.006 inch. This corresponded to the inner extremity of the fracture zone; the darker etched field originated at this point. Hardness values were found to be R_c 57; these remained constant to the midpoint of the section. Beyond this point, the values decreased to R_c 50 and remained at this level to the opposite surface.

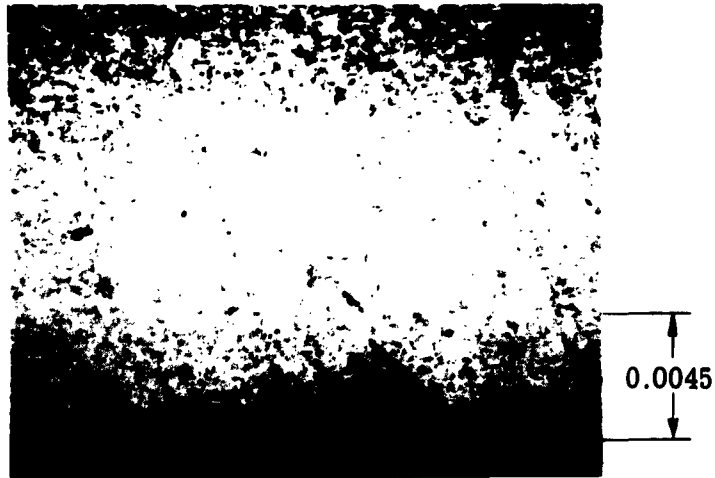
Figure 7. Secondary Fracture of 18-9-5 Mar-aging Steel (about 250X, Schantz Etch)

The single zone also contained a 45-degree crack, which was 0.007 inch below the plane of the origin, that had propagated in this harder area and had extended 0.006 inch into the material. Polishing the specimen below the level of the crack resulted in the gradual disappearance of the harder zone and the crack; the grooves and softer surface areas persisted. It appears that the presence of the thin surface layer of softer material was not related to this failure. The failure was, therefore, attributed to the zone of harder, less ductile material in combination with the grooved condition of the surface. This defect was probably aggravated during the first pressure cycle used to delaminate the joint. Figure 21 shows the vessel just after the test. The failure is a longitudinal break completely around the periphery of the internal ring joining the header to the rest of the vessel. The metallurgical evaluation and the photomicrographs are presented in subsection II B of this report.

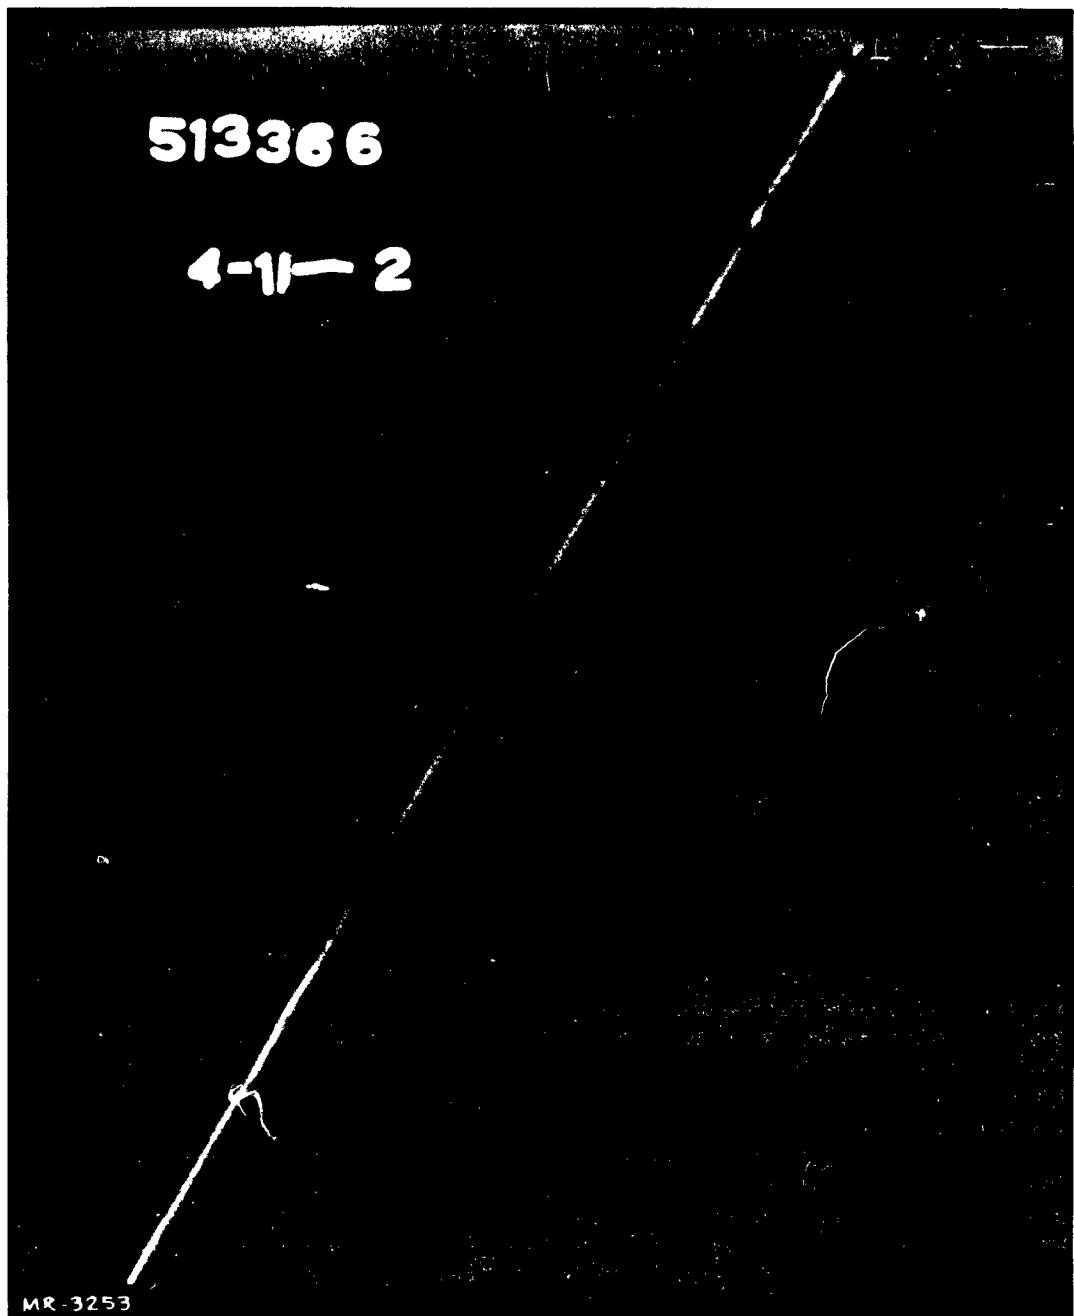
V-202**	5	0.075	FM1000	1520	240,000	Failure originated in a weldment in the central inner ring. Examination showed no unusual conditions in the weld. Uniaxial tensile strengths of weldments tested range from 243,000 to 263,000 psi.
V-301**	6	0.124	FM1000	2290	219,000	Failure due to unbonded area in one header joint (approximately 20 percent of area). Preliminary evaluation attributed this condition to the stiffness of the work-horse header preventing uniform contact pressure during the cure cycle.
<p>* The detailed report on vessel III-101 is in the "Fourth Quarterly Progress Report," RAC 1160. ** See Section III.</p>

revealed no unusual conditions. X-ray photographs of the weldment before and after failure are shown in Figures 26 and 27. Figure 28 shows an over-all view of the assembly after test; a close-up of the primary failure zone is shown in Figure 29. It is noteworthy that this view shows that the edge of the inner ring containing the weld failure remained bonded to the outside ring. Another view (Figure 30) of the reconstructed assembly shows the position of the weldments in the outer rings on the surface opposite the primary failure. The inner ring containing the weld along which the failure originated was delaminated; this ring is shown in Figure 31.

Figure 26. X-ray of Weldment in Ring before Test (V-202)

Figure 27. X-ray of Weldment after Hydrostatic Test of Assembly V-202
